PROJECT: Proposed Tiggervalleij Extension 9	TRAIL HOLE: 76 TOETSGAT:	SHEET No: 1 Vel Nr:
SITE: A Part of the Remainder of the Farm	LOGGED FJB	DATE: 25 May 2006
CLIENT: Sable Homes North (Pty) Ltd KLIENT:	LOCATION: 25° 46' 33,9" S 28° 22' 48,7" E

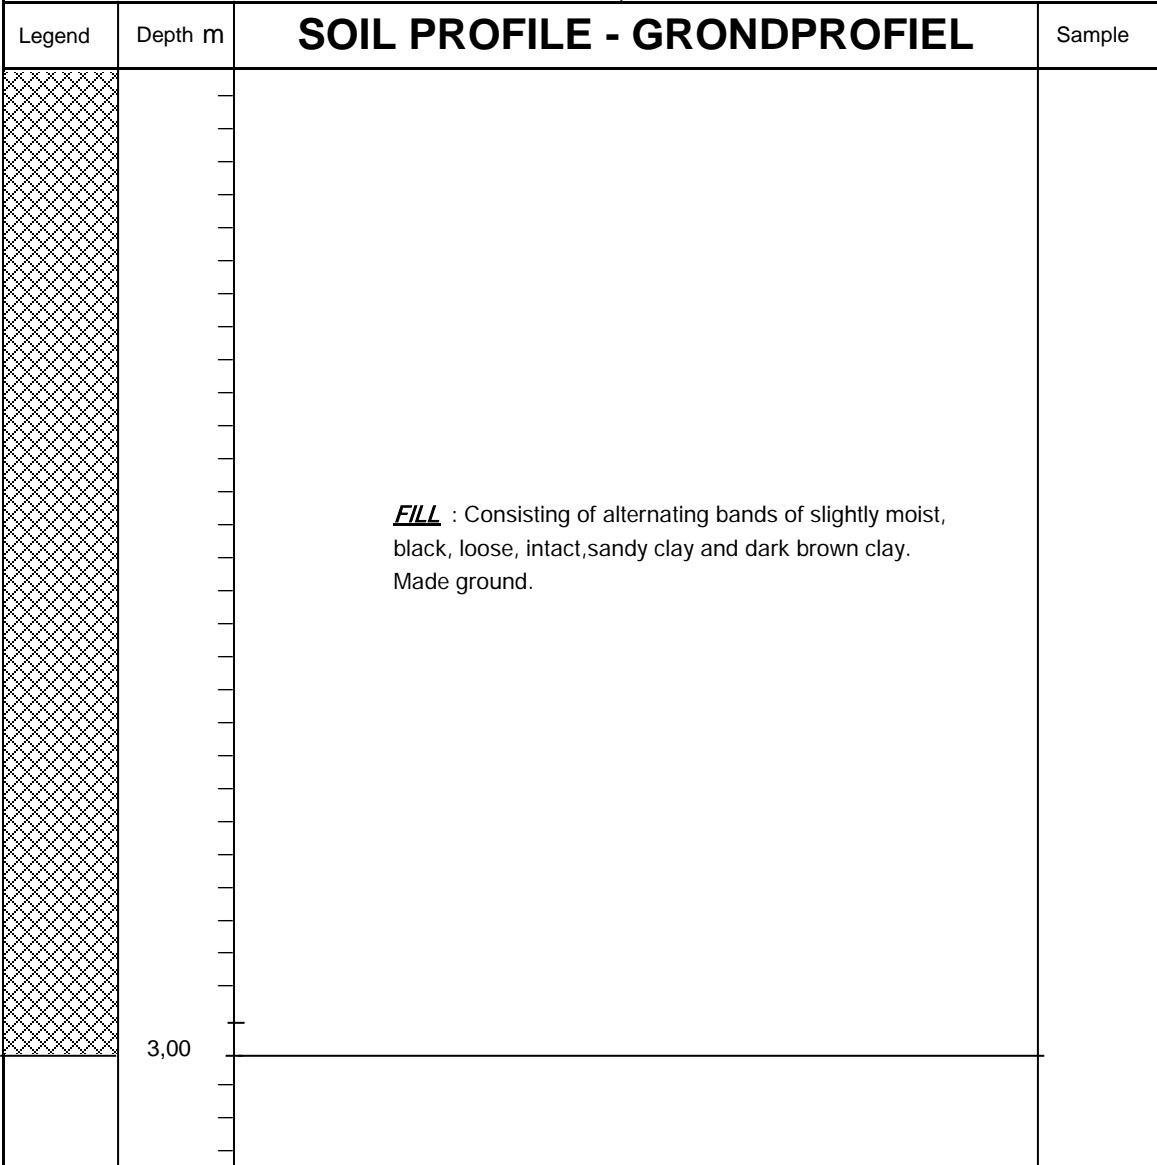
FIG A76

Water encountered Water teëgekom	Contractor: SNALAB Kontrakteur:	NOTES / NOTAS 1 Refusal of excavation at 3000mm on very hard rock, shale. 2 Seepage water not encountered.
 	Water level Waterrusvlak		
 	Bottom of hole Bodem van gat	Date Drilled: 17 March 2006 Datum Geboor:	
 	Approximate material change Benaderde materiaalverandering	Machine: John Deere 310A Masjien:	
---	Disturbed sample Versteurde monster		
 	Undisturbed sample Onversteurde monster	Hole diameter: 700mm Gat deursnee:	
 	Consolidation sample Konsolidasie monster		
C	Indicator tests Klassifikasie toets	Water depth: Watervlak:	
I

SOIL	SOIL PROFILE : TEST PIT 76
-------------	-----------------------------------

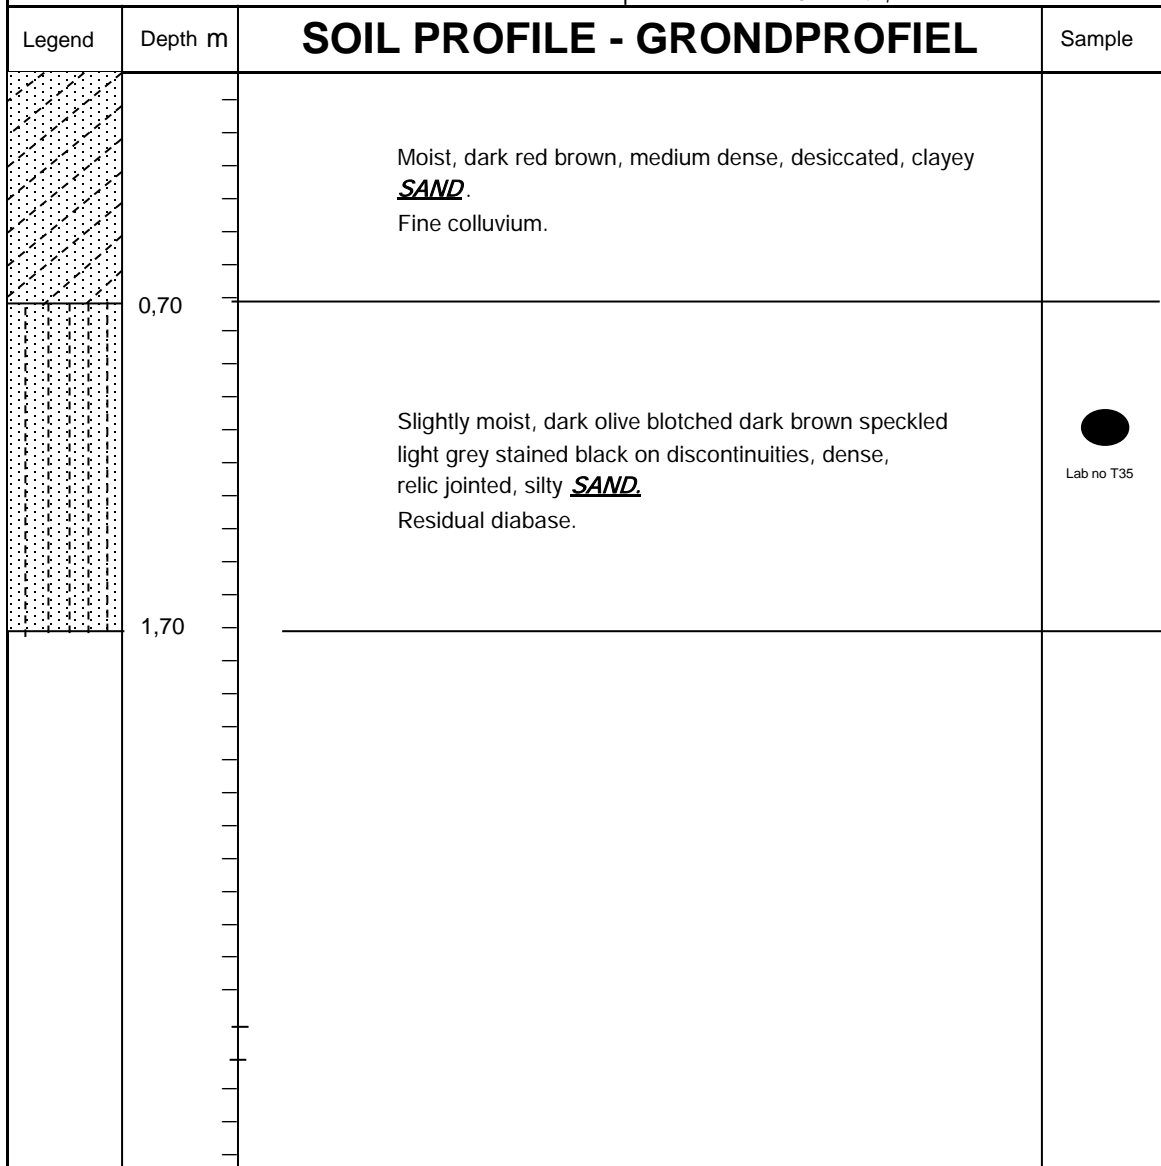
FIG A77

Water encountered Water teëgekom	Contractor: SNALAB	NOTES / NOTAS 1 Refusal of excavation encountered at 1700mm on very hard rock, diabase. 2 Seepage water not encountered.
	Water level Waterrusvlak	Kontrakteur:	
	Bottom of hole Bodem van gat	Date Drilled: 16 March 2006 Datum Geboor:	
	Approximate material change	Machine: John Deere 310A Masjien:	
	Benaderde materiaalverandering Disturbed sample	Hole diameter: 700mm Gat deursnee:	
	Versteurde monster Undisturbed sample	Water depth: Watervlak:	
	Onversteurde monster Consolidation sample Konsolidasie monster		
C	Indicator tests Klassifikasie toets		
I

SOIL	SOIL PROFILE : TEST PIT 77
-------------	-----------------------------------

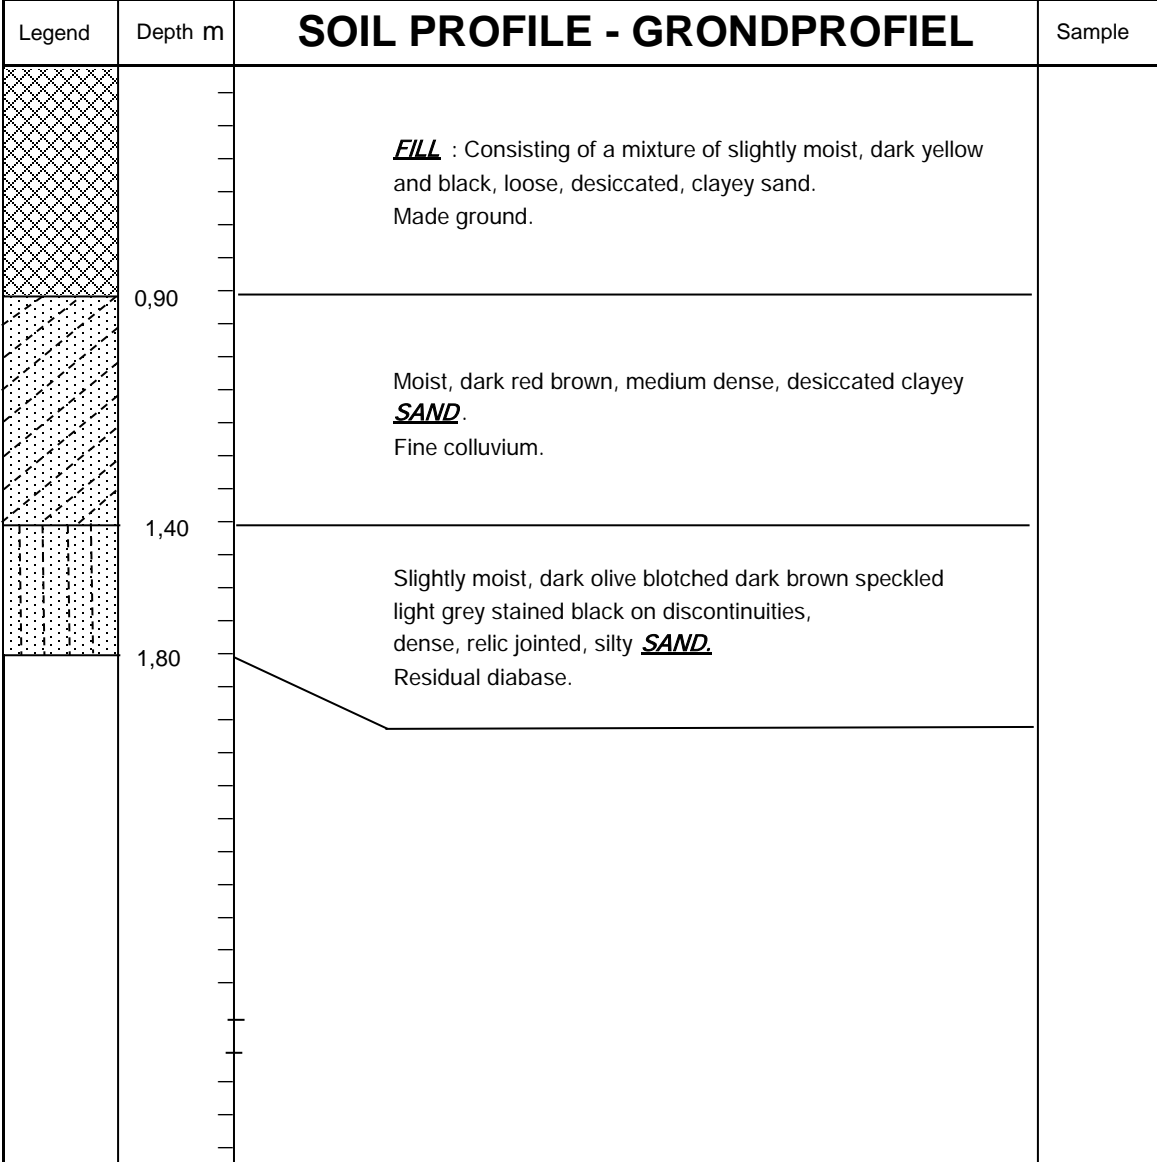
FIG A78

Water encountered Water teëgekom	Contractor: SNALAB	NOTES / NOTAS 1 Refusal of excavation not encountered. 2 Seepage water not encountered.
	Water level Waterrusvlak	Date Drilled: 16 March 2006	
	Bottom of hole Bodem van gat	Datum Geboor:	
	Approximate material change	Machine: John Deere 310A	
	Benaderde materiaalverandering Disturbed sample	Masjien:	
	Versteurde monster Undisturbed sample	Hole diameter: 700mm	
	Onversteurde monster Consolidation sample Konsolidasie monster	Gat deursnee:	
C	Indicator tests Klassifikasie toets	Water depth:	
I		Watervlak:

SOIL	SOIL PROFILE : TEST PIT 78
-------------	-----------------------------------

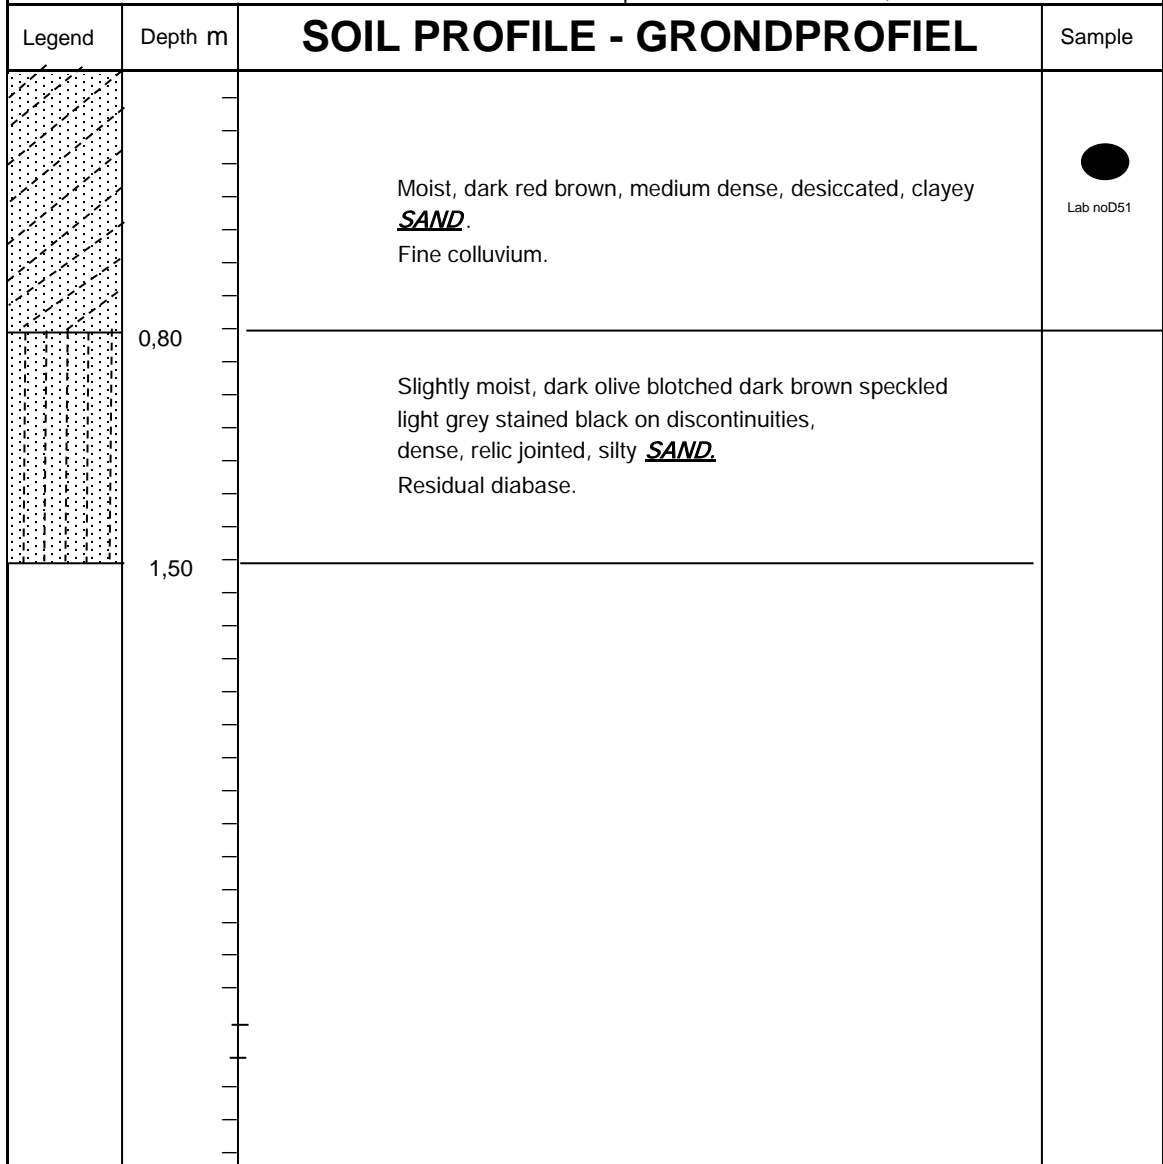
FIG A79

Water encountered Water teëgekom	Contractor: SNALAB	NOTES / NOTAS 1 Refusal of excavation not encountered. 2 Seepage water not encountered.
	Water level Waterrusvlak	Date Drilled: 16 March 2006	
	Bottom of hole Bodem van gat	Datum Geboor:	
	Approximate material change	Machine: John Deere 310A	
	Benaderde materiaalverandering Disturbed sample	Masjien:	
	Versteurde monster Undisturbed sample	Hole diameter: 700mm	
	Onversteurde monster Consolidation sample Konsolidasie monster	Gat deursnee:	
C	Indicator tests Klassifikasie toets	Water depth:	
I		Watervlak:

SOIL	SOIL PROFILE : TEST PIT 79
-------------	-----------------------------------

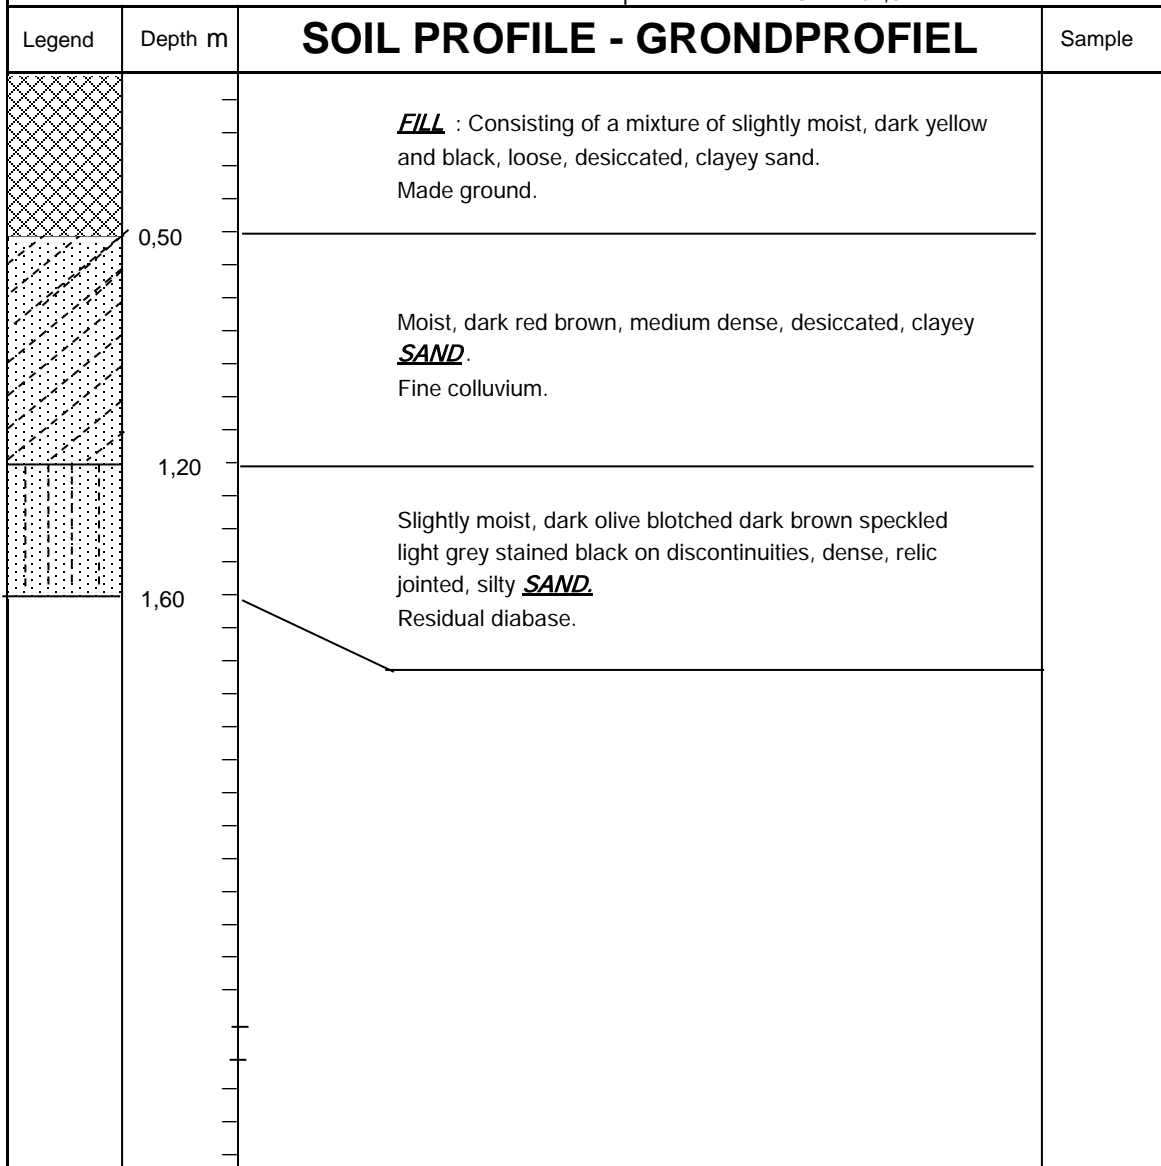
FIG A80

Water encountered Water teëgekom	Contractor: SNALAB Kontrakteur:	NOTES / NOTAS 1 Refusal of excavation encountered at 1600mm on very hard rock, DIABASE. 2 Seepage water not encountered.

SOIL	SOIL PROFILE : TEST PIT 80
-------------	-----------------------------------

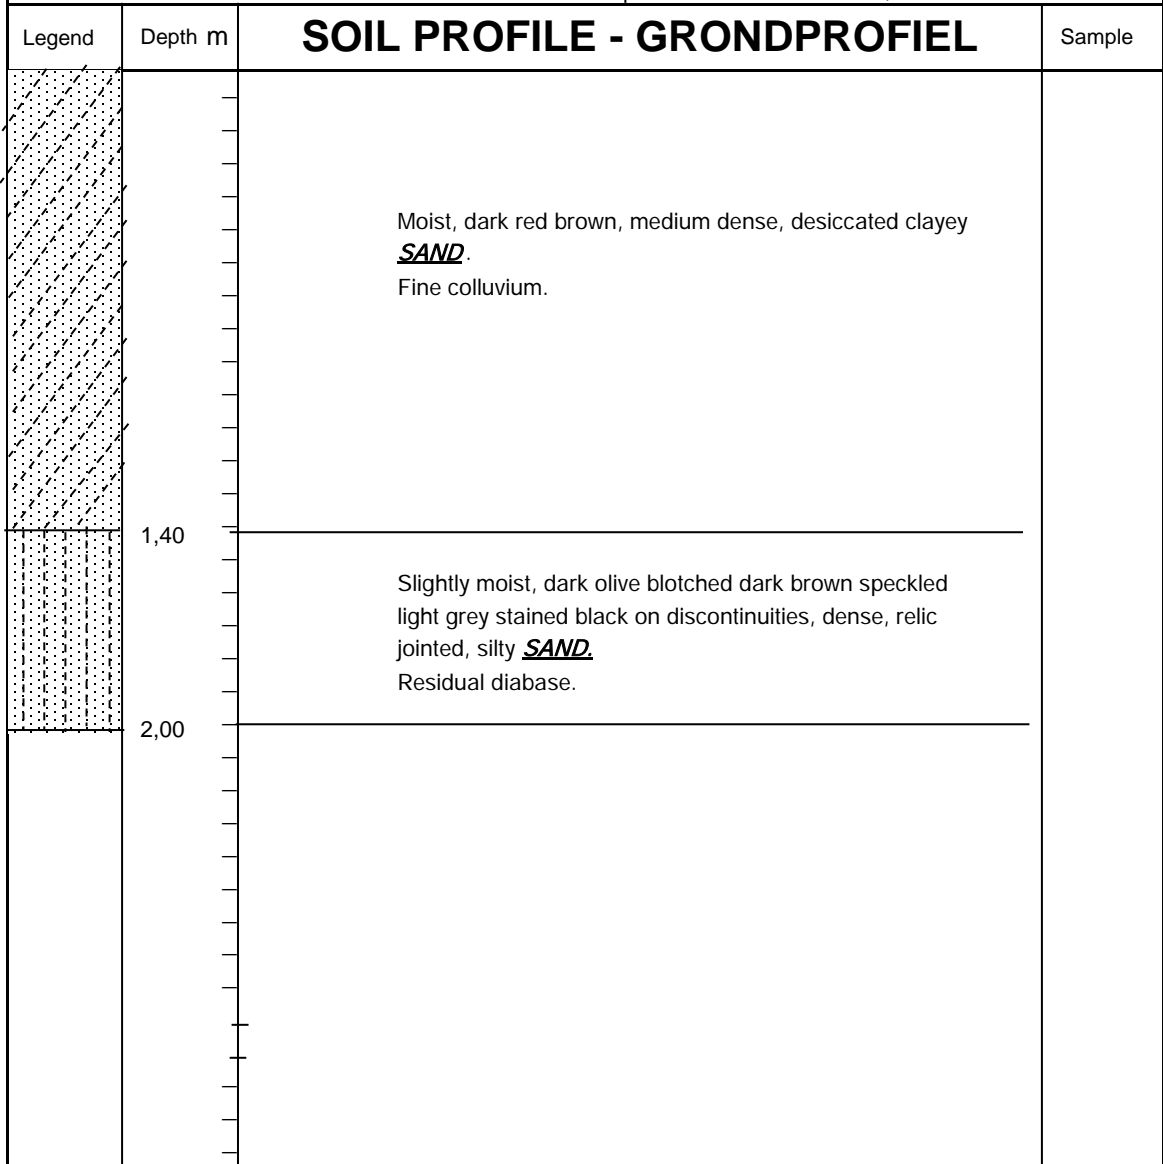
FIG A81

Water encountered Water teëgekom	Contractor: SNALAB	NOTES / NOTAS 1 Refusal of excavation not encountered. 2 Seepage water not encountered.
	Water level Waterrusvlak	Date Drilled: 16 March 2006	
	Bottom of hole Bodem van gat	Datum Geboor:	
	Approximate material change	Machine: John Deere 310A	
	Benaderde materiaalverandering Disturbed sample	Masjien:	
	Versteurde monster Undisturbed sample	Hole diameter: 700mm	
	Onversteurde monster Consolidation sample Konsolidasie monster	Gat deursnee:	
C	Indicator tests Klassifikasie toets	Water depth:	
I		Watervlak:

SOIL	SOIL PROFILE : TEST PIT 81
-------------	-----------------------------------

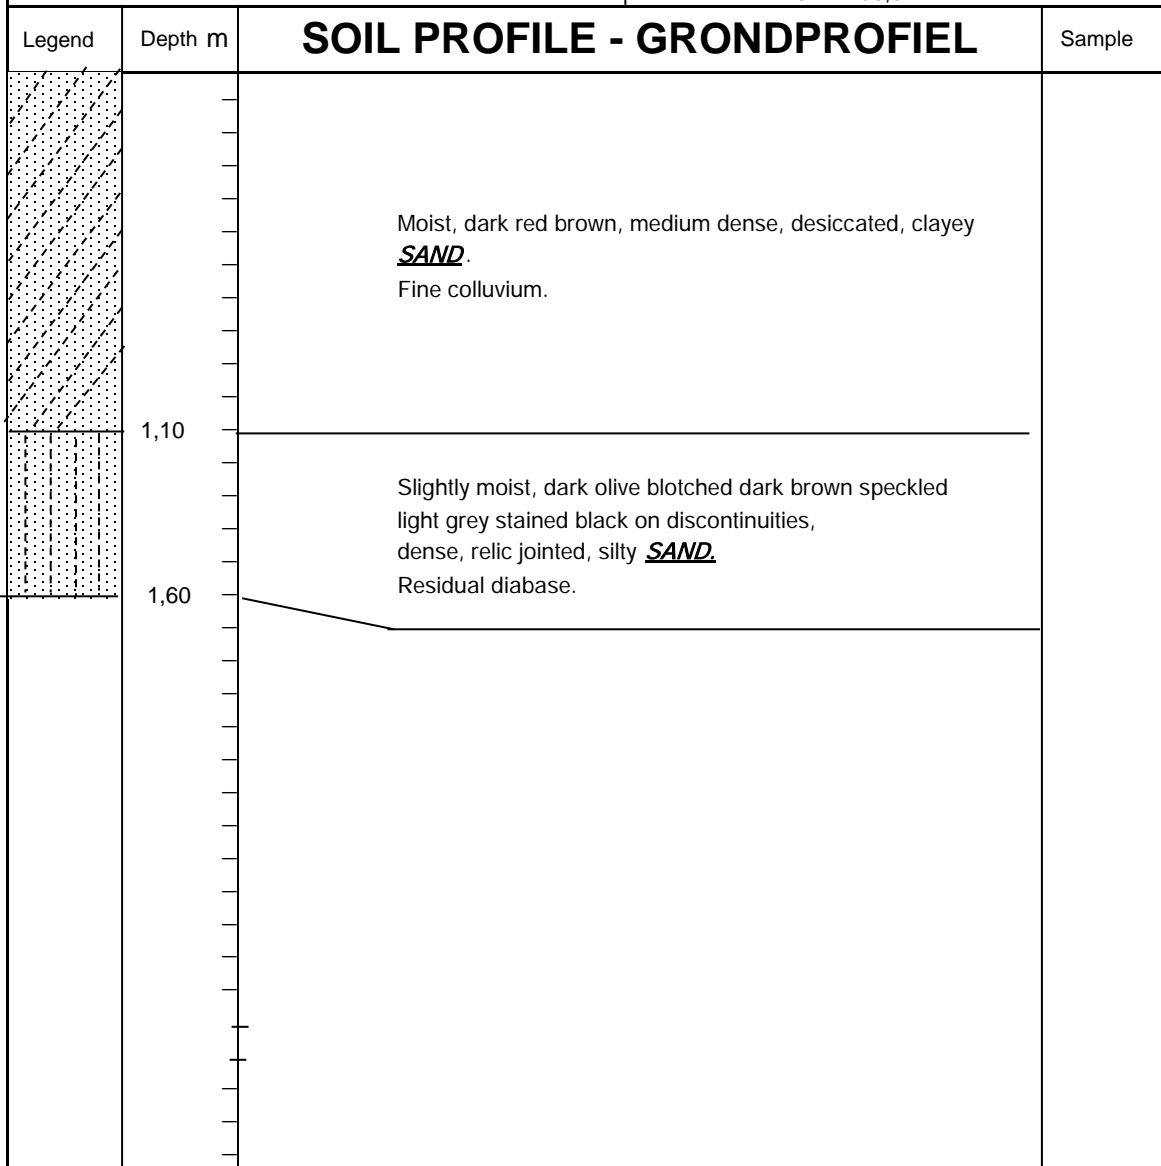
FIG A82

Water encountered Water teëgekom	Contractor: SNALAB	NOTES / NOTAS 1 Refusal of excavation not encountered. 2 Seepage water not encountered.

SOIL	SOIL PROFILE : TEST PIT 82
-------------	-----------------------------------

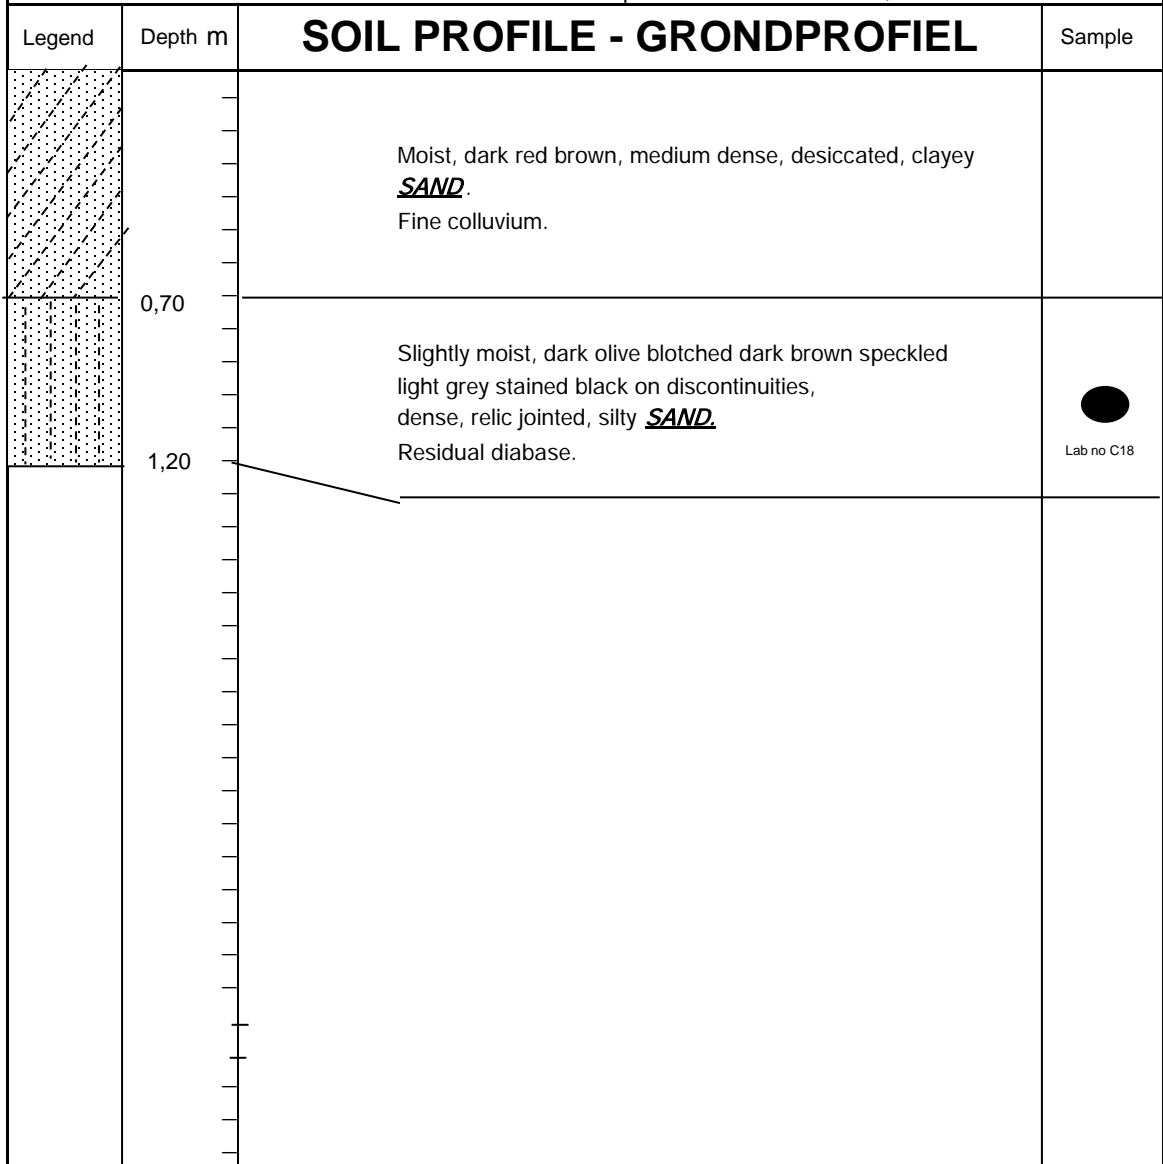
FIG A83

Water encountered Water teëgekom	Contractor: SNALAB	NOTES / NOTAS 1 Refusal of excavation encountered at 1200 mm on very hard ROCK. 2 Seepage water not encountered.

SOIL	SOIL PROFILE : TEST PIT 83
-------------	-----------------------------------

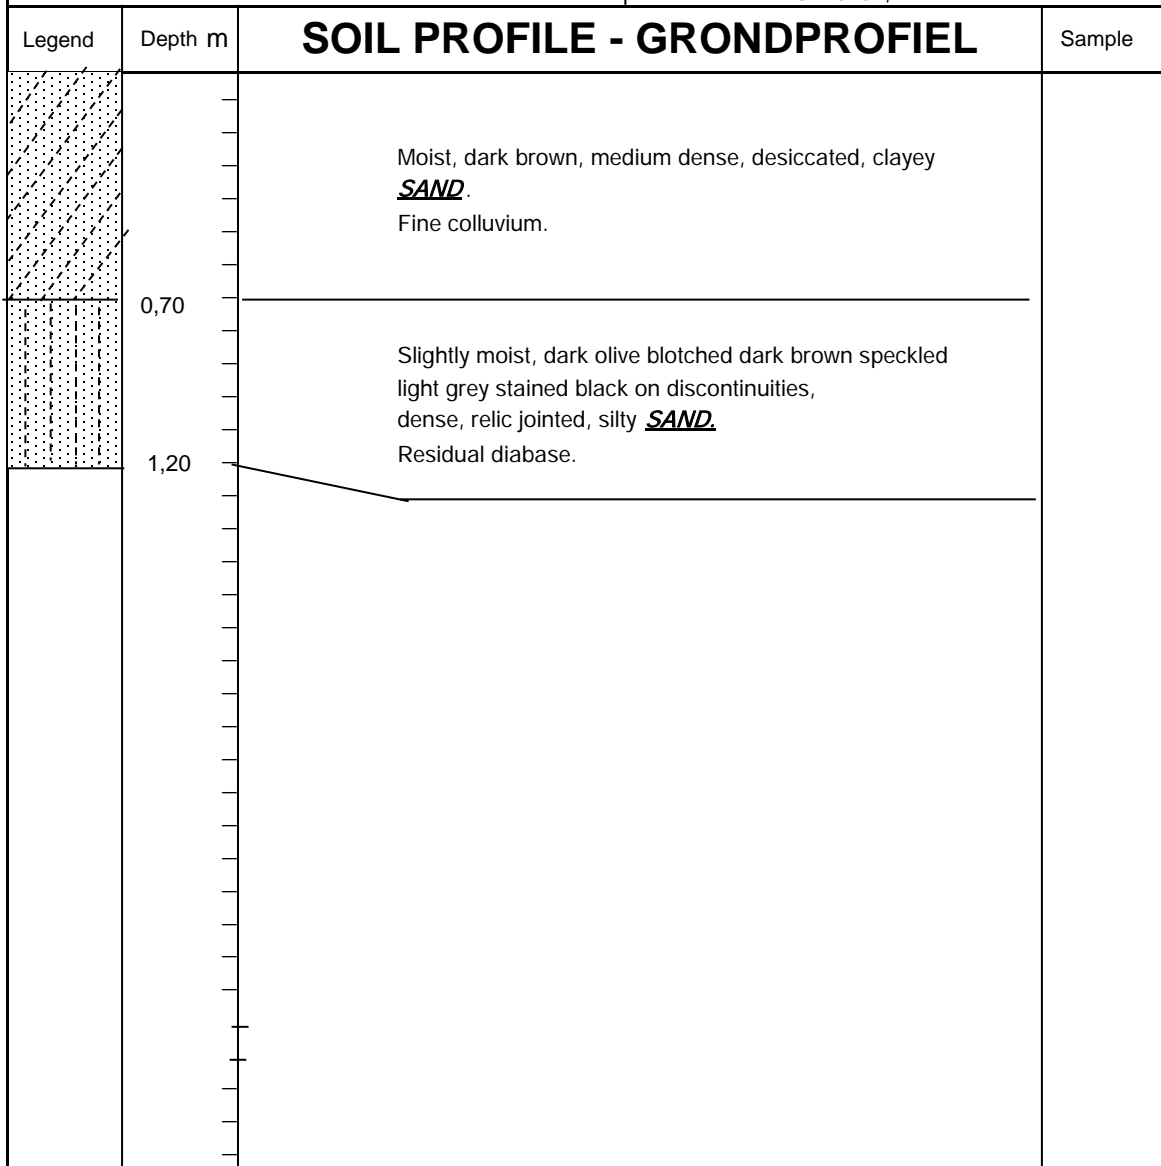
FIG A84

Water encountered Water teëgekom	Contractor: SNALAB	NOTES / NOTAS 1 Refusal of excavation encountered at 1200 mm on very hard ROCK. 2 Seepage water not encountered.

SOIL	SOIL PROFILE : TEST PIT 84
-------------	-----------------------------------

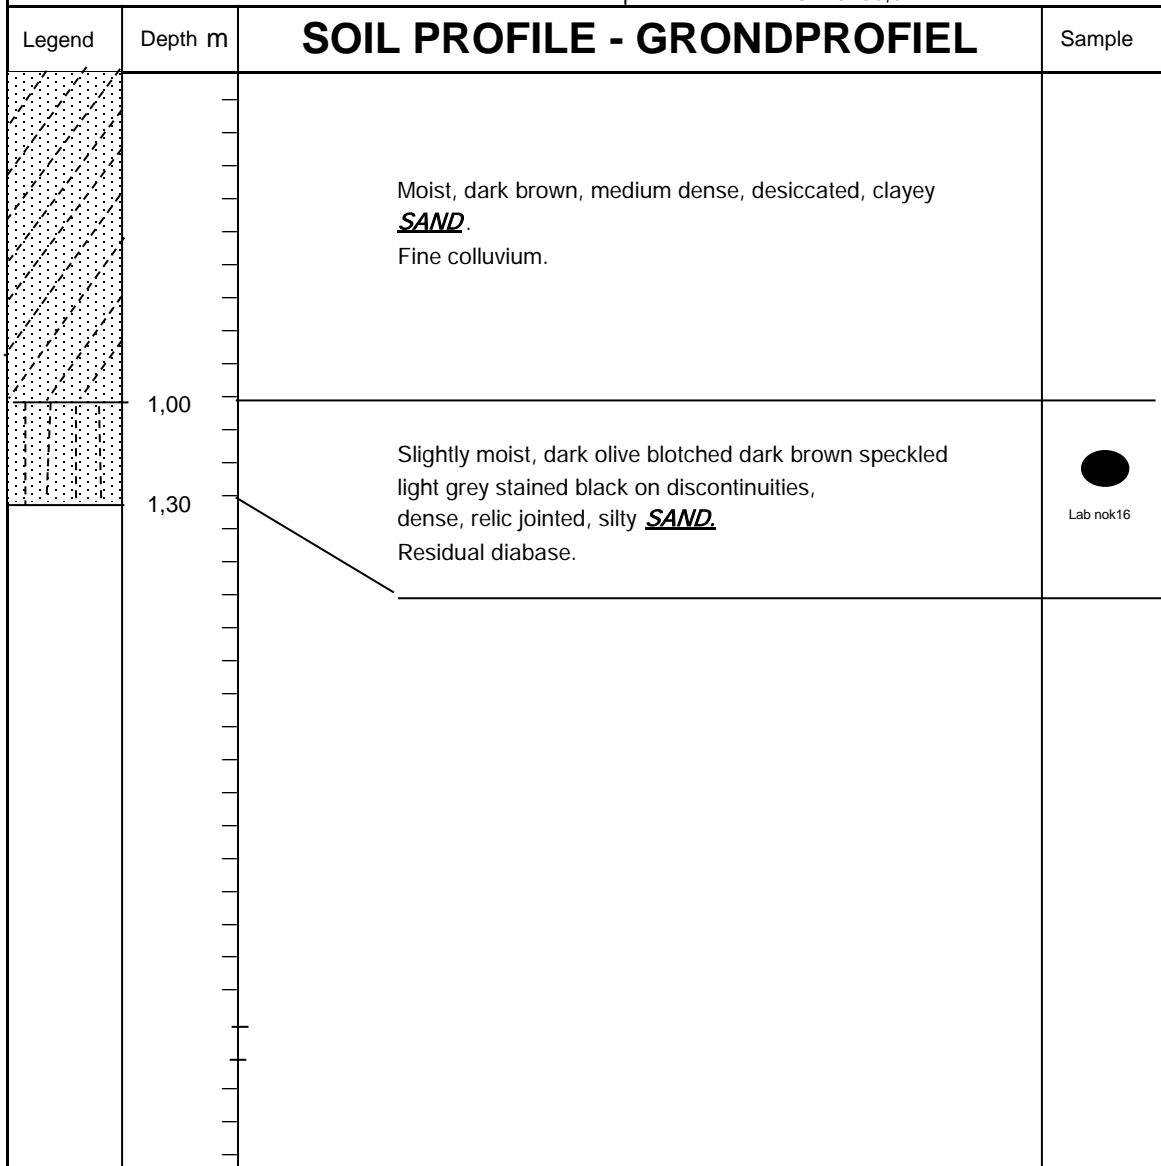
FIG A85

Water encountered Water teëgekom	Contractor: SNALAB	NOTES / NOTAS 1 Refusal of excavation not encountered. 2 Seepage water not encountered.
	Water level Waterrusvlak	Date Drilled: 16 March 2006	
	Bottom of hole Bodem van gat	Datum Geboor:	
	Approximate material change	Machine: John Deere 310A	
	Benaderde materiaalverandering Disturbed sample	Masjien:	
	Versteurde monster Undisturbed sample	Hole diameter: 700mm	
	Onversteurde monster Consolidation sample Konsolidasie monster	Gat deursnee:	
C	Indicator tests Klassifikasie toets	Water depth:	
I		Watervlak:

SOIL	SOIL PROFILE : TEST PIT 85
-------------	-----------------------------------

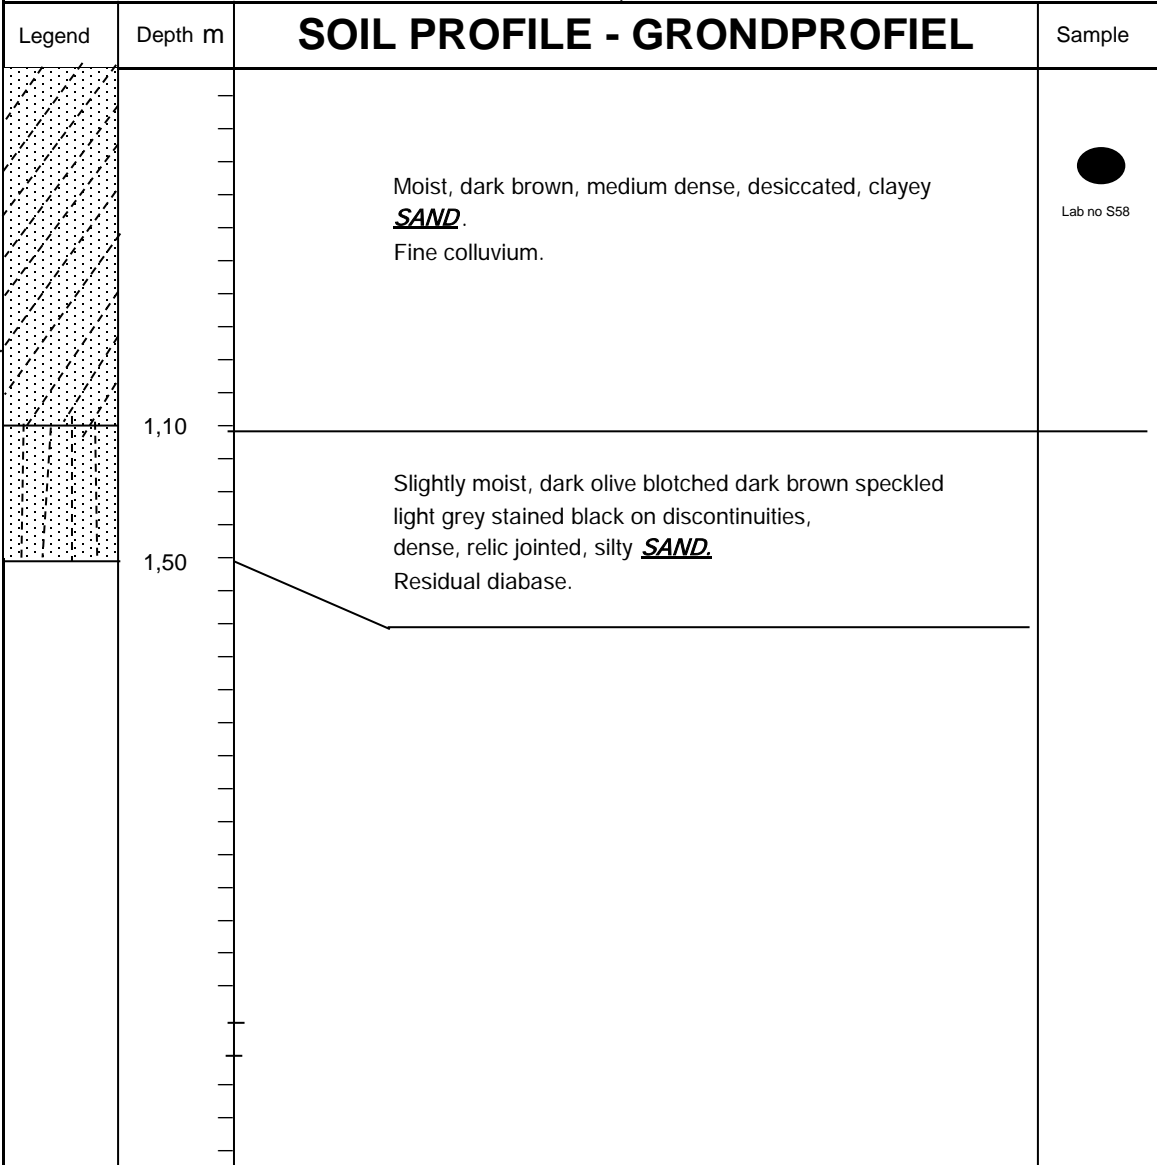
FIG A86

Water encountered Water teëgekom	Contractor: SNALAB	NOTES / NOTAS 1 Refusal of excavation not encountered. 2 Seepage water not encountered.
	Water level Waterrusvlak	Date Drilled: 16 March 2006	
	Bottom of hole Bodem van gat	Datum Geboor:	
	Approximate material change	Machine: John Deere 310A	
	Benaderde materiaalverandering Disturbed sample	Masjien:	
	Versteurde monster Undisturbed sample	Hole diameter: 700mm	
	Onversteurde monster Consolidation sample Konsolidasie monster	Gat deursnee:	
C	Indicator tests Klassifikasie toets	Water depth:	
I		Watervlak:

SOIL	SOIL PROFILE : TEST PIT 86
-------------	-----------------------------------

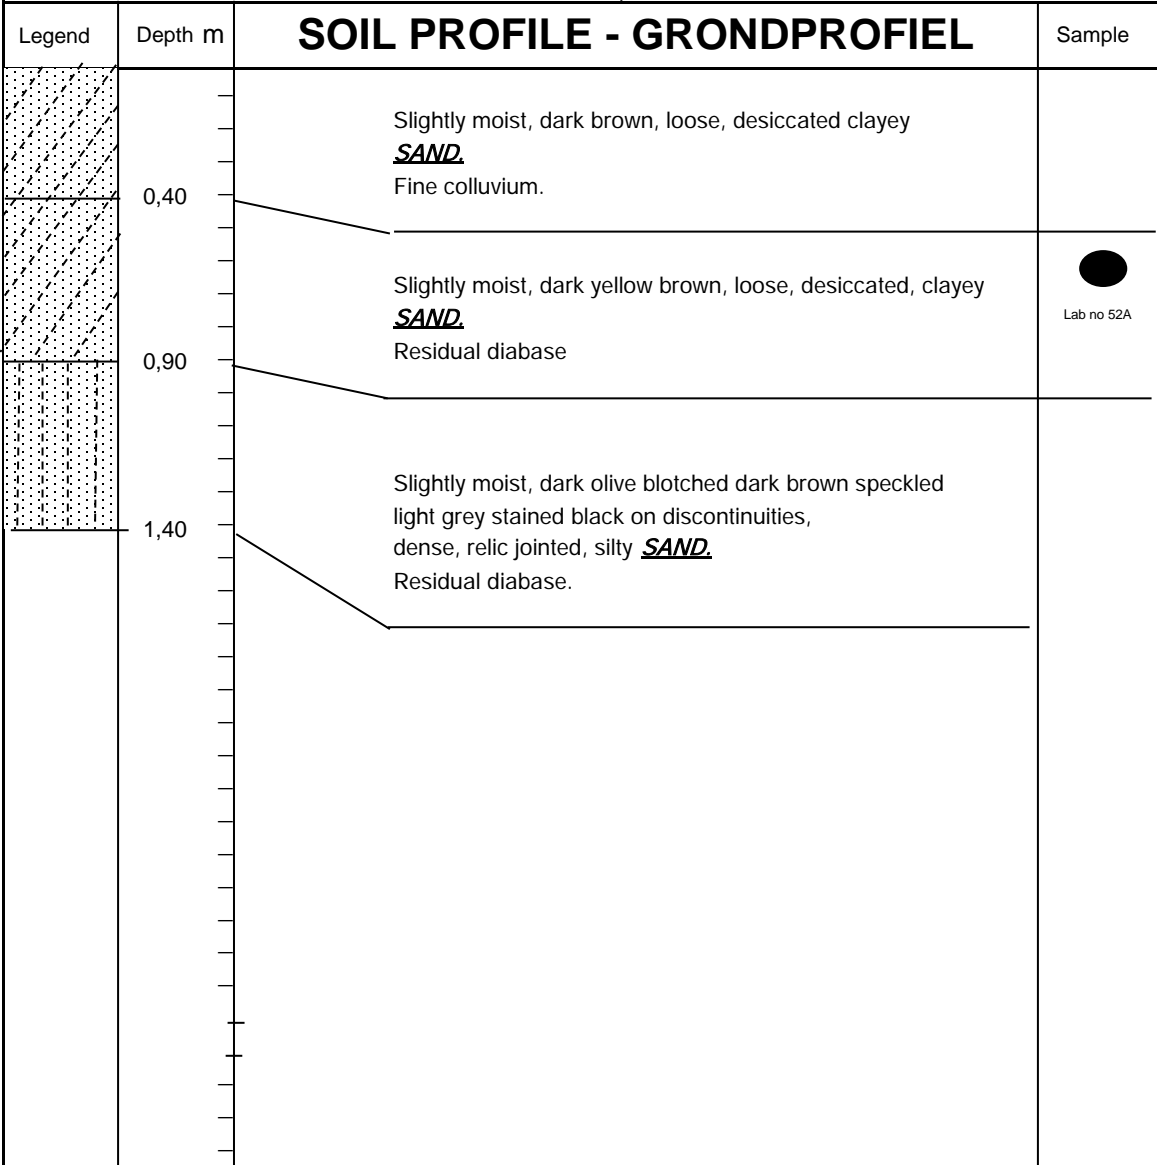
FIG A87

Water encountered Water teëgekom	Contractor: SNALAB	NOTES / NOTAS 1 Refusal of excavation not encountered. 2 Seepage water not encountered.
	Water level Waterrusvlak	Date Drilled: 16 March 2006	
	Bottom of hole Bodem van gat	Datum Geboor:	
	Approximate material change	Machine: John Deere 310A	
	Benaderde materiaalverandering Disturbed sample	Masjien:	
	Versteurde monster Undisturbed sample	Hole diameter: 700mm	
	Onversteurde monster Consolidation sample Konsolidasie monster	Gat deursnee:	
C	Indicator tests Klassifikasie toets	Water depth:	
I		Watervlak:

SOIL	SOIL PROFILE : TEST PIT 87
-------------	-----------------------------------

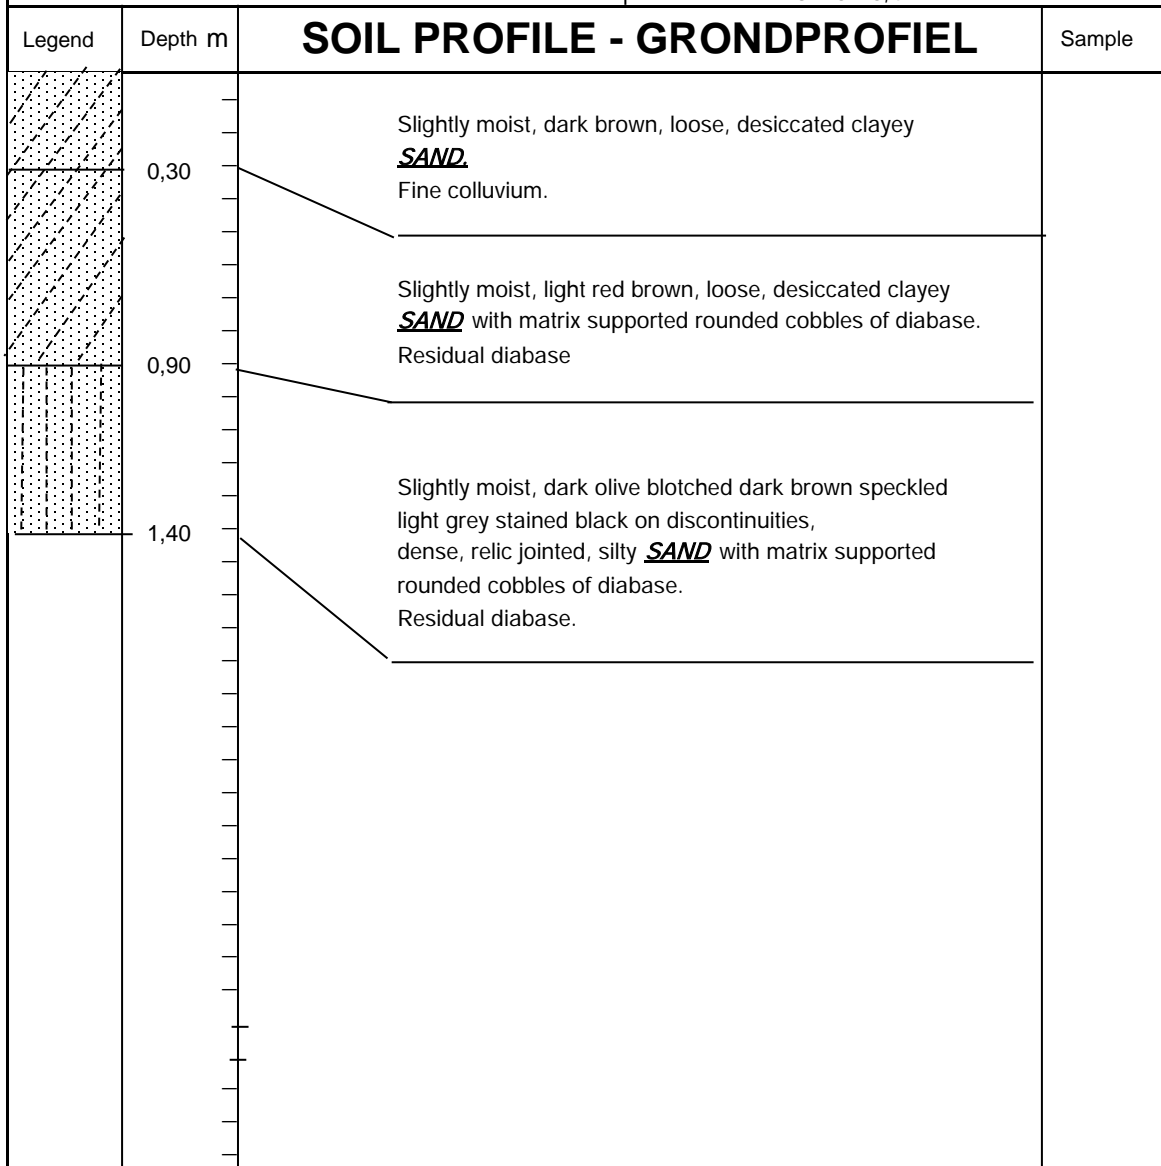
FIG A88

Water encountered Water teëgekom	Contractor: SNALAB	NOTES / NOTAS 1 Refusal of excavation not encountered. 2 Seepage water not encountered.
	Water level Waterrusvlak	Date Drilled: 16 March 2006	
	Bottom of hole Bodem van gat	Datum Geboor:	
	Approximate material change Benaderde materiaalverandering	Machine: John Deere 310A	
	Disturbed sample Versteurde monster	Masjien:	
	Undisturbed sample Onversteurde monster	Hole diameter: 700mm	
	Consolidation sample Konsolidasie monster	Gat deursnee:	
C	Indicator tests Klassifikasie toets	Water depth:	
I		Watervlak:

SOIL	SOIL PROFILE : TEST PIT 88
-------------	-----------------------------------
